**PB90-910406  
NTSB/AAR-90/06**

**AIRCRAFT ACCIDENT REPORT**

**UNITED AIRLINES FLIGHT 232  
McDONNELL DOUGLAS DC-10-10  
SIOUX GATEWAY AIRPORT  
SIOUX CITY, IOWA  
JULY 19, 1989**

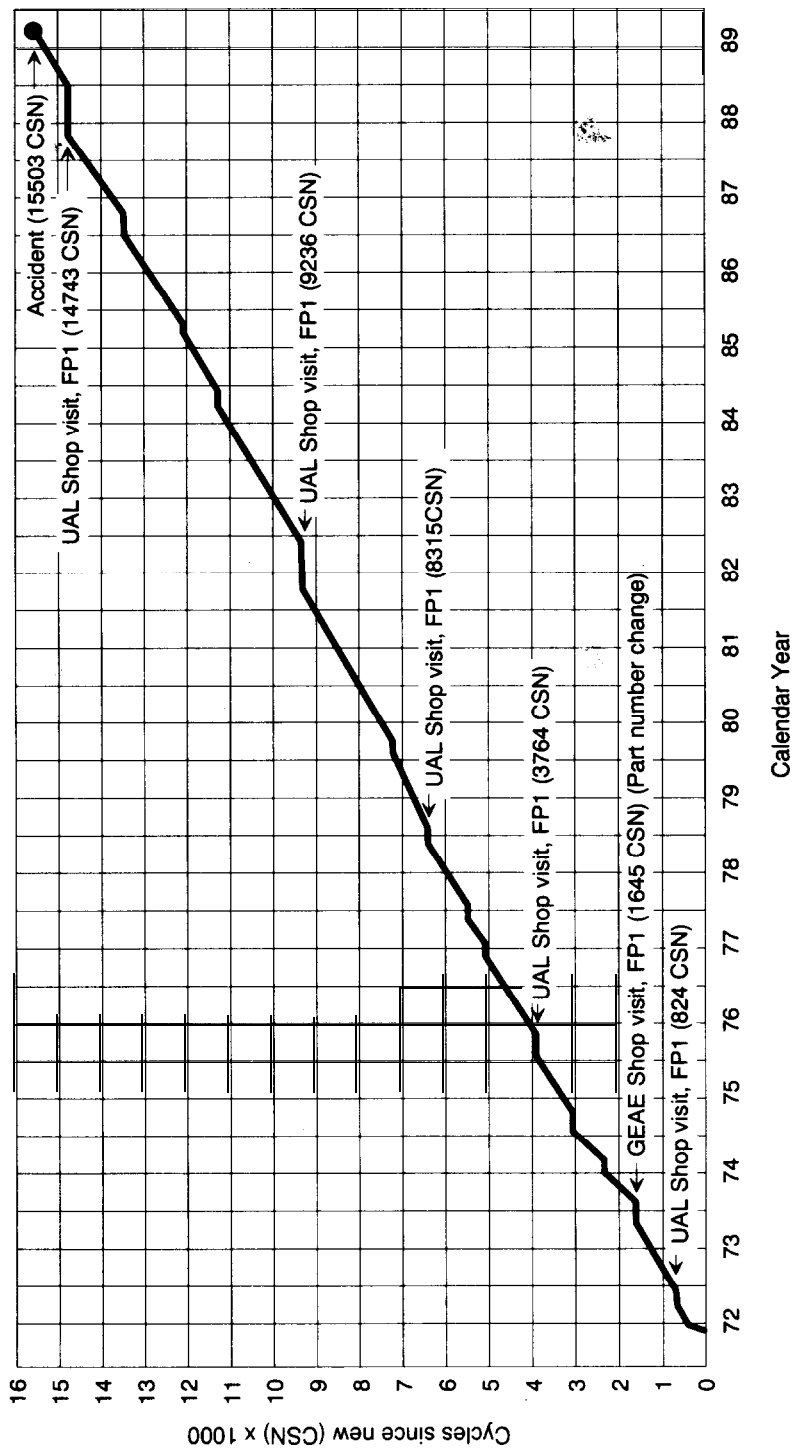
Figure 9.--- Inspection history of accident fan disk.  
(Data source GEAE)

During the next 17 years, the engines in which this stage 1 fan disk were installed were routinely overhauled and the fan module was disassembled. The disk was removed on the following dates for inspection: September 1972, November 1973, January 1976, June 1978, February 1982 and February 1988. This disk was accepted after each of six fluorescent penetrant inspections (FPI).<sup>2</sup> (See figure 9). Five of the six inspections were performed at the UAL CF6 Overhaul Shop in San Francisco, California. One of them was performed at the GEAE Airline Service Department in Ontario, California, in 1973. At the time of the accident, the stage 1 fan disk had accumulated 41,009 hours and 15,503 cycles since new. The last shop visit in February 1988, was 760 flight cycles before the accident, and FPI was performed at that time. The engine had been removed because of corrosion in the high pressure turbine (HPT) stage 1 nozzle guide vanes. At that time, the stage 1 fan disk had accumulated 38,839 hours and 14,743 cycles since new. Following this inspection, the disk was installed in engine S/N 451-243, the No. 2 engine on the accident airplane.

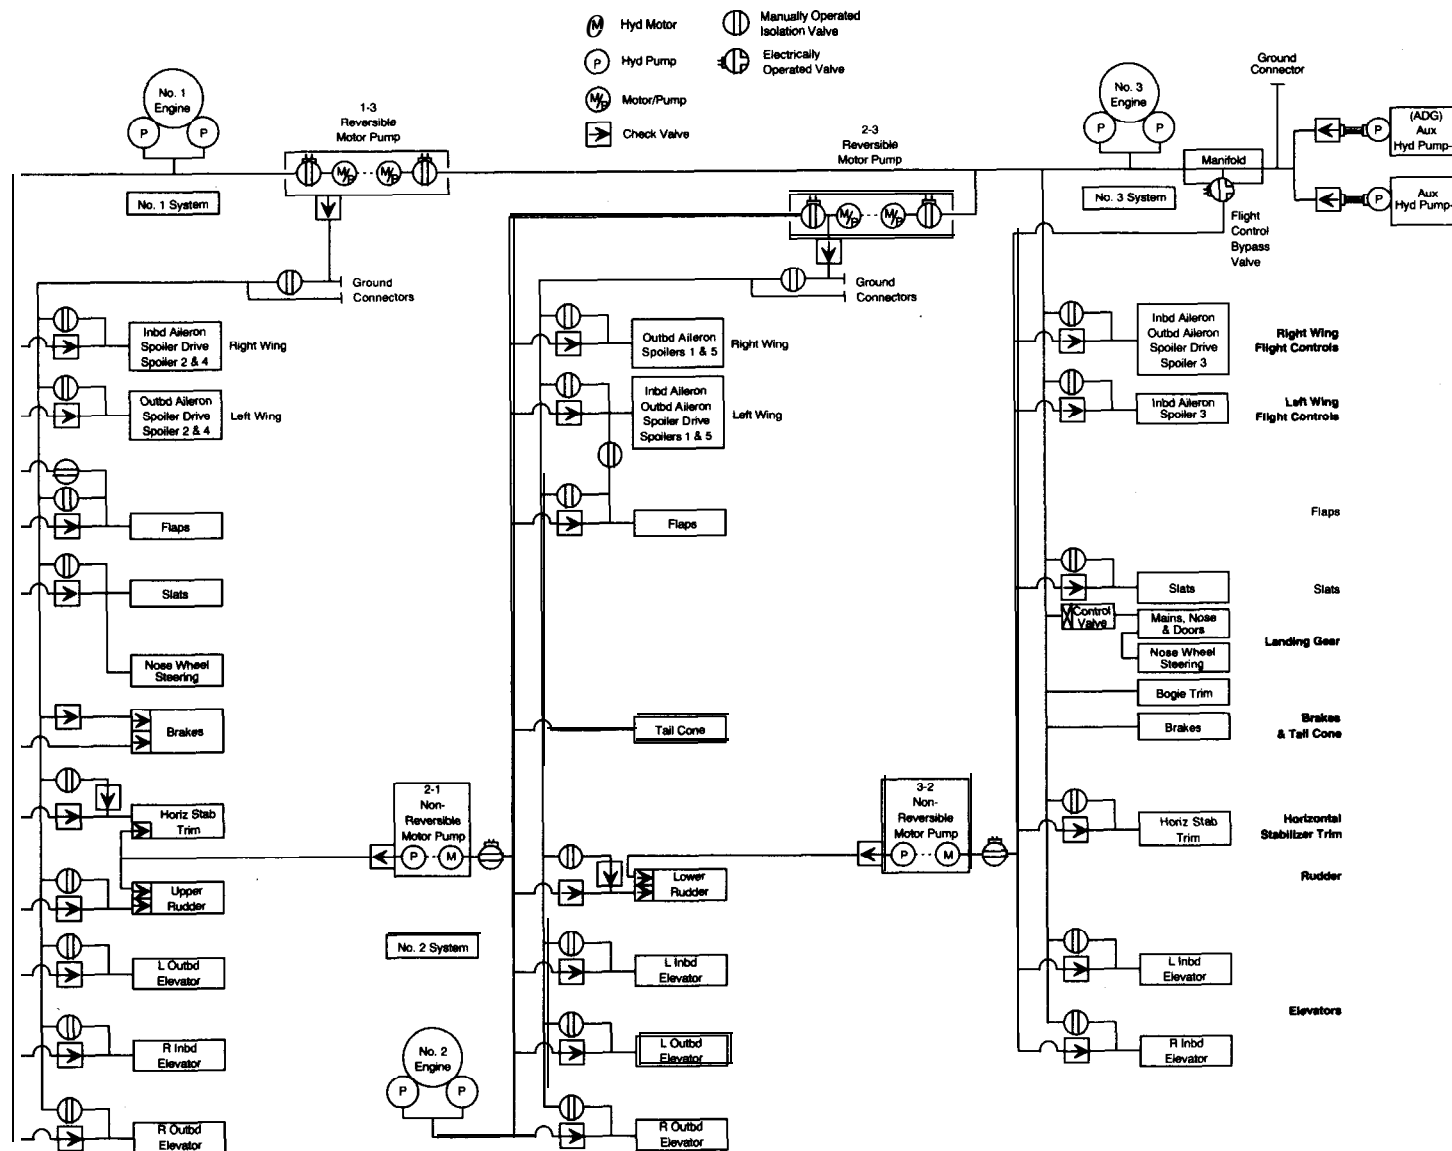
Figure 10.--DC-10 hydraulic system schematic.

The hydraulic components and piping are physically separated to minimize the vulnerability of the airplane to multiple hydraulic system failures in the event of structural damage. The No. 1 hydraulic system lines run along the left side of the fuselage to the rear of the airplane and along the front spar of the horizontal stabilizer and the vertical stabilizer. The No. 2 hydraulic system lines are routed from the center engine along the rear spar of the horizontal and vertical stabilizers. The No. 3 hydraulic system lines run along the right side of the fuselage to the tail area and along the rear spar of the horizontal stabilizer. The No. 2 hydraulic system lines are not routed forward of the rear wing spar, in order to isolate them from wing engine fragmentation, and No. 3 hydraulic system lines in the tail section

are not routed aft of the inboard elevator actuators in order to minimize exposure to possible engine fragmentation damage from the tail-mounted engine.

The DC-10-10 hydraulic system was designed by the manufacturer and demonstrated to the FAA to comply with 14 CFR 25.901, which in part specified that, "no single [powerplant] failure or malfunction or probable combination of failures will jeopardize the safe operation of the airplane...."

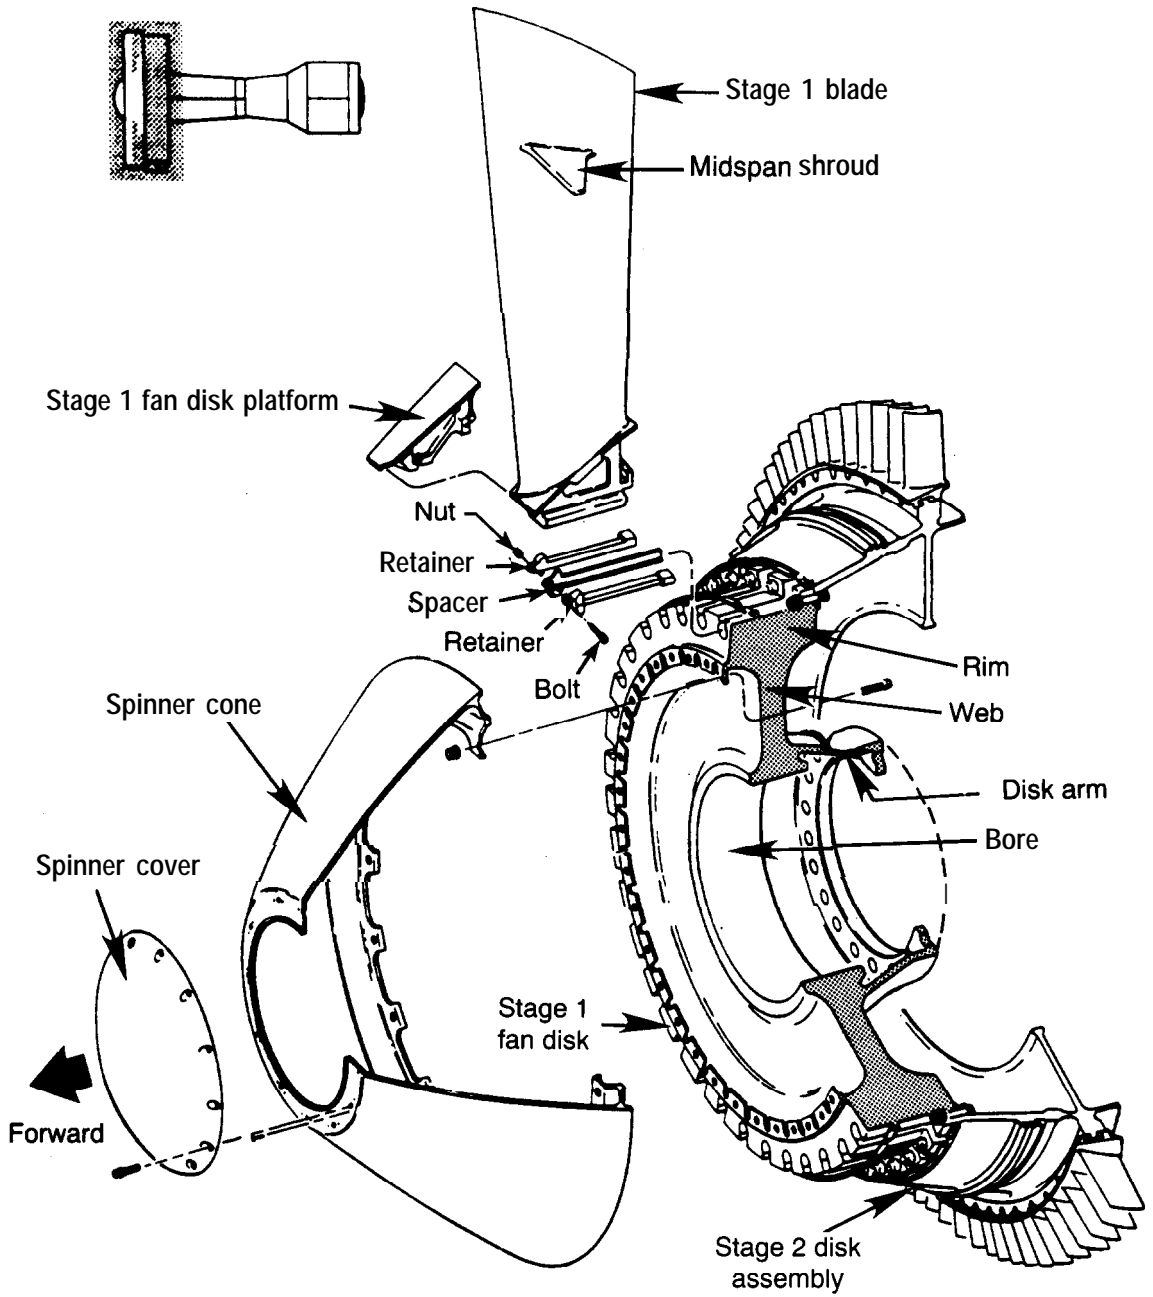
Figure 16. --Fan rotor assembly.

Figure 16 shows a drawing of a **CF6-6** engine fan rotor assembly, most of which departed the No. 2 engine of the accident airplane in flight. The assembly consists of the large stage 1 disk and attached fan blades and retainers, the smaller stage 2 disk and attached blades, the spinner cone and cover, and various mounting and balancing hardware. A cutaway view of the engine in the area of the stage 1 disk is shown in figure 17.

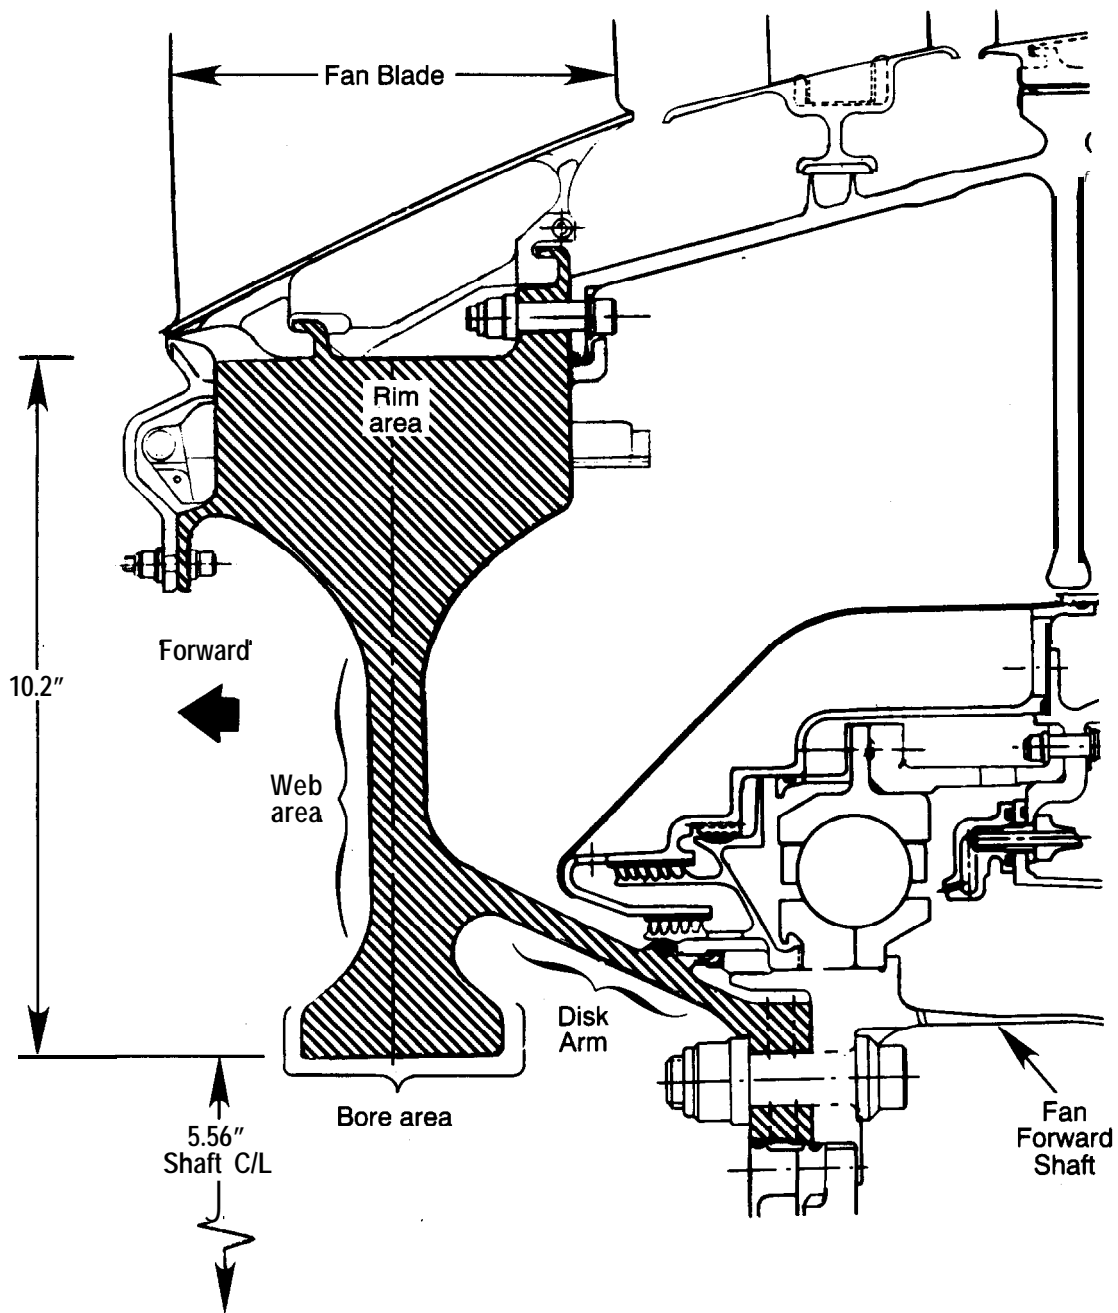
Figure 17.--CF6-6 engine stage 1 fan disk cutaway view - disk highlighted.

The stage 1 fan disk weighs 370 pounds and is a machined titanium alloy forging about 32 inches in diameter. GEAE convention refers to various portions of the disk as the rim, the bore, the web, and the disk arm, as labeled in figure 17. The rim is about 5 inches thick and is the outboard portion of the disk. The rim contains the axial "dovetail" slots, which retain the fan blades. Also, the stage 2 fan disk is bolted to the aft face of the rim. The bore is about 3 inches thick and is the enlarged portion of the disk adjacent to the 11-inch-diameter center hole. Extending between the rim and bore is the disk web, which is about 0.75 inch thick. The conical disk arm extends aft from the web at a diameter of about 16 inches. The conical arm diameter decreases in the aft direction to about 10 inches at the disk arm flange where the disk bolts to the fan forward shaft (also labeled in figure 17).

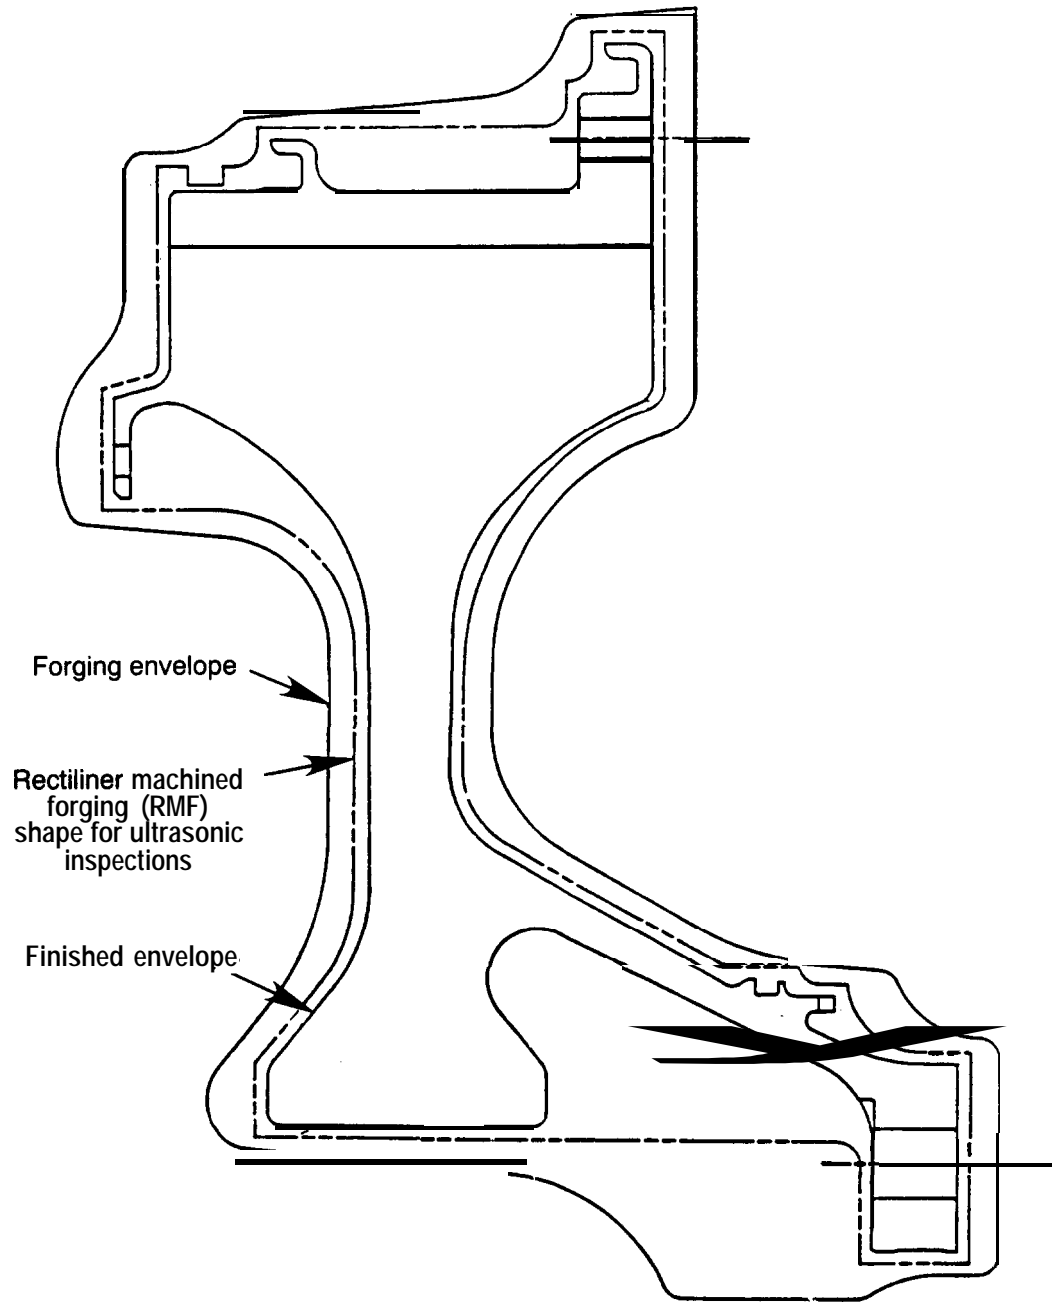
*Figure 20. --CF6-6 stage 1 fan disk envelopes at various stages of manufacture.*

During the records search for the manufacturing routing package of stage 1 fan disk S/N MPO 00385, it was learned that two rough machined forgings<sup>9</sup> (referred to as disk "A" and "B") having this same serial number had been routed through GEAE manufacturing. Actual receiving documentation at GEAE could not be located. Figure 20 depicts the three shapes of the disk during the manufacturing process.

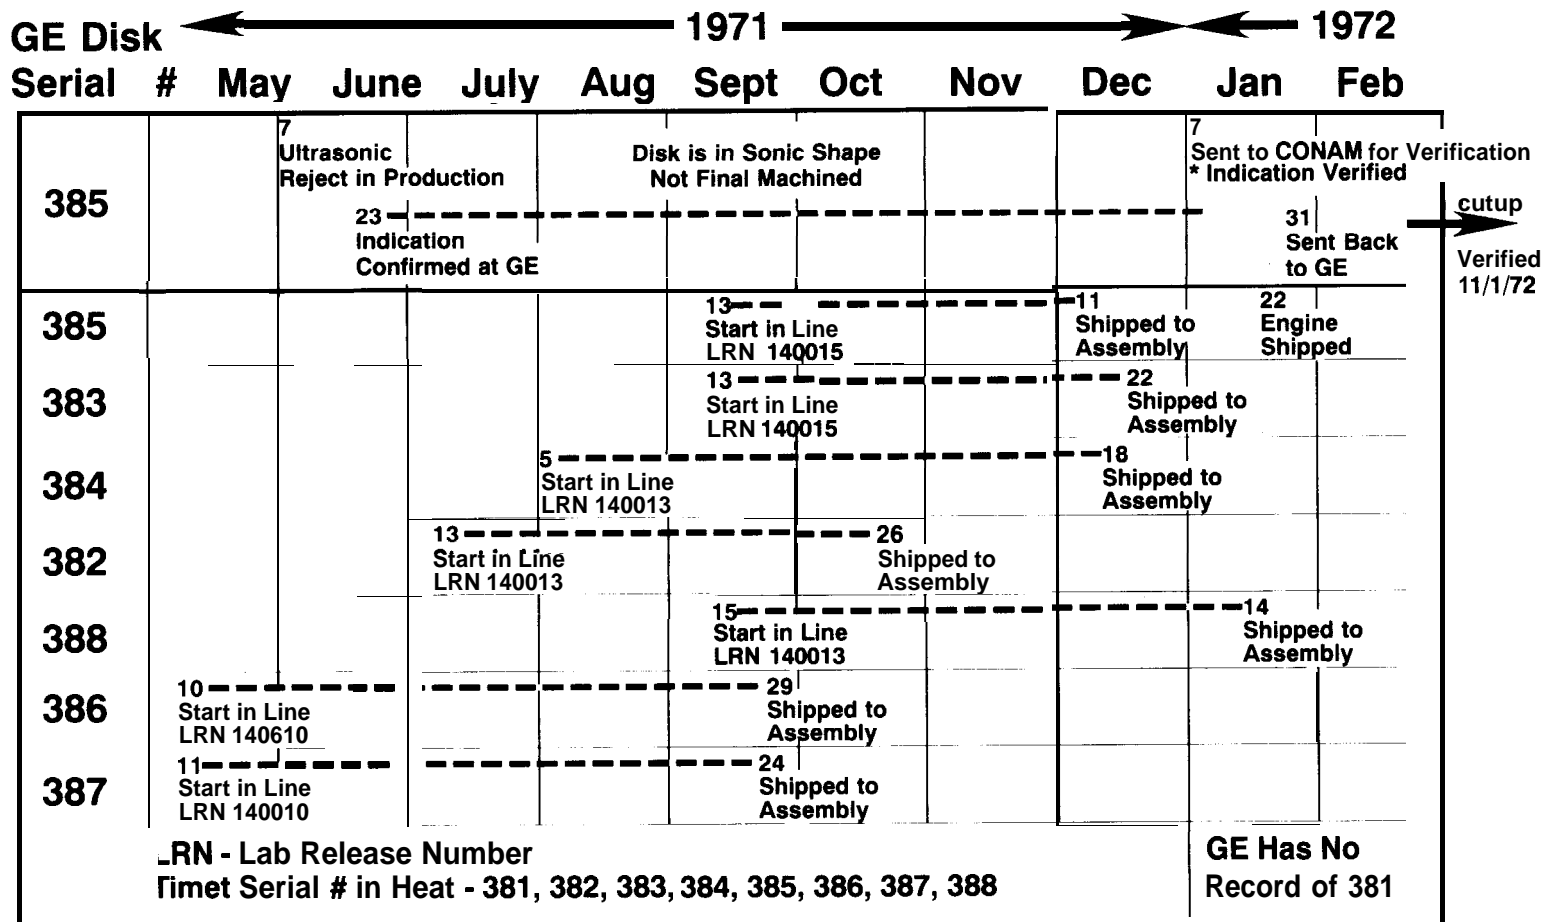
Figure 21. -- Calendar history of manufacturing activity of heat K8283 prepared by GEAE.

The calendar history of the GEAE manufacturing activity for the eight forgings reported by ALCOA as comprising heat K8283 is shown in tabular summary. (See figure 21). Although ALCOA records indicate that a forging S/N AJV 00381 was produced from TIMET heat K8283, no record of this forging or disk could be found at GEAE.
